McKinney Fire Restoration Project

The McKinney Fire Restoration Project intends to identify short- and long-term remedial measures to reduce impacts to water quality, salmonid and other aquatic species' habitat, water supply reliability, public safety and infrastructure affected by the fire through a process of data

McKinney Fire Watershed Response Report

the Preliminary Reconnaissance Habitat Impacts Assessment and Remediation Recommendations, McKinney Fire, Siskiyou County, California

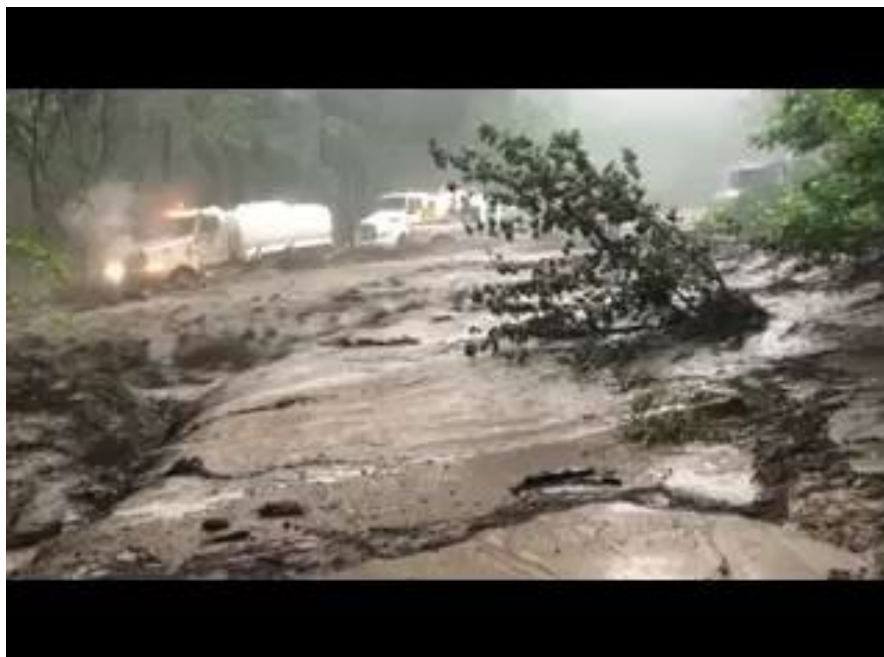
At 8 pm in the evening of August 2, 2022, flash flooding was reported in Humbug Creek with the bridge crossing being challenged. At the same time Vesa and Little Humbug creeks were flooding and producing debris flows blocking the Walker Road. By 9:15 pm the storm moved off the eastern half of the fire and continued east (see pictures below).

Humbug Creek mudflow near OHV park

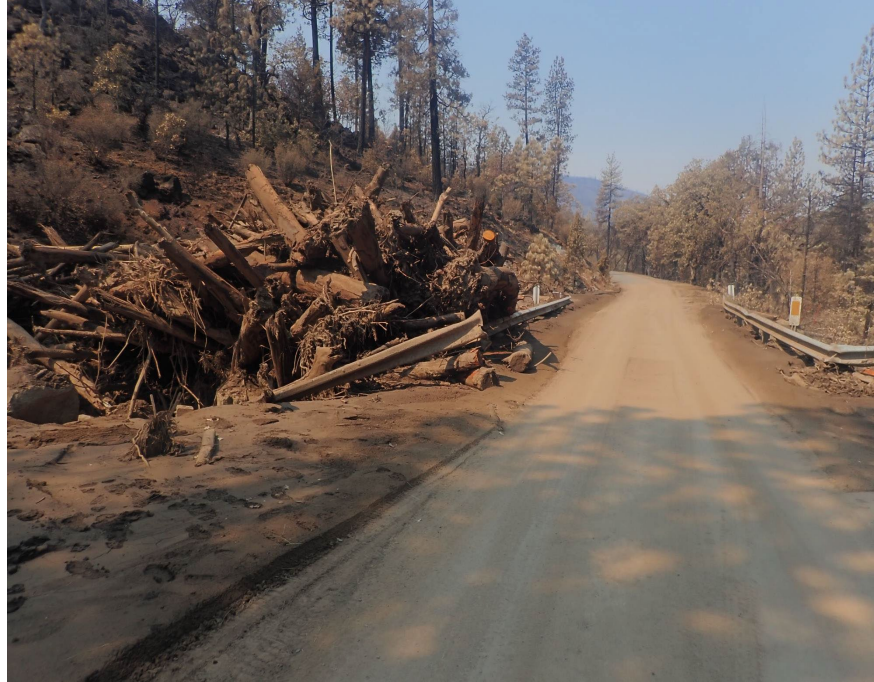
Little Humbug Creek Walker Road crossing

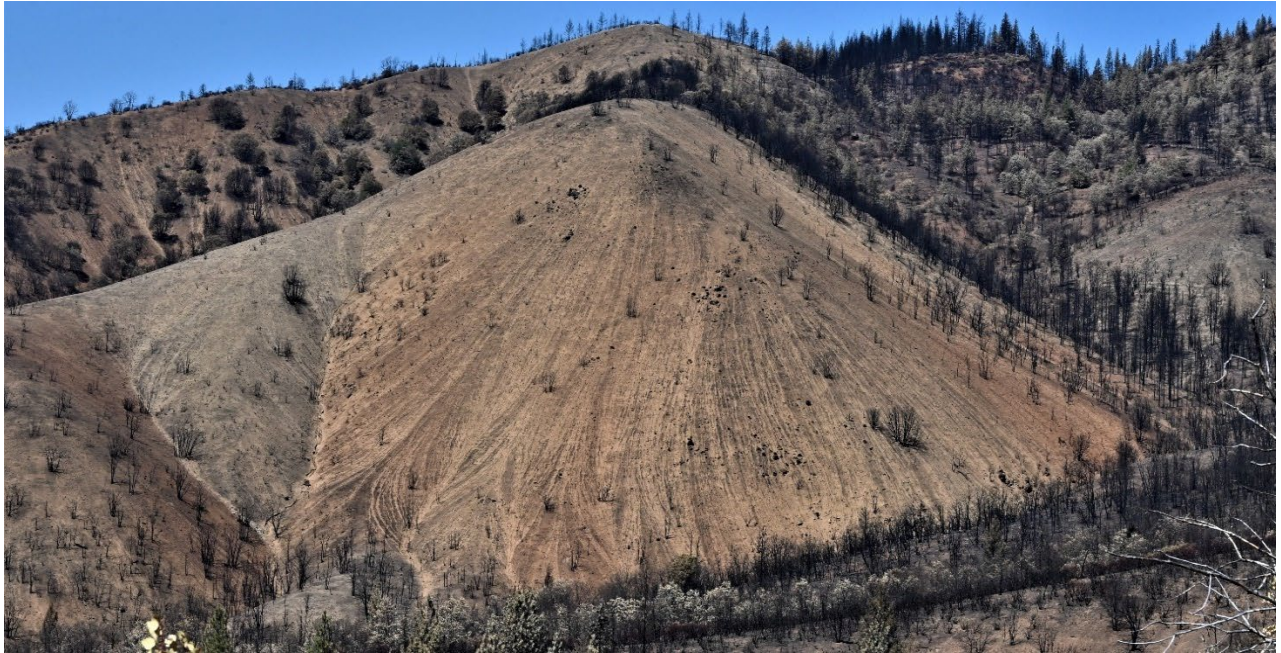
Figure 5 is a dramatic display of rilling on a hillslope that was located at the center of the storm. Because the soil loses most of its soil cover in Moderate and High SBS, the water runs off the surface unimpeded without organic soil cover. Unfortunately, water repellency was exacerbated by long term drought because the microbial component in the soil that attenuates water repellency was disrupted in dry soil so utilization of the water repellent compounds are outpaced by the deposition. This significantly increases runoff speed which increases stream peak flow and debris flow potential. What may be concerning is that the surface of the soil that burned at Moderate and High Soil Burn

Figure 5. Illustration of extensive rilling patterns within the core of the storm

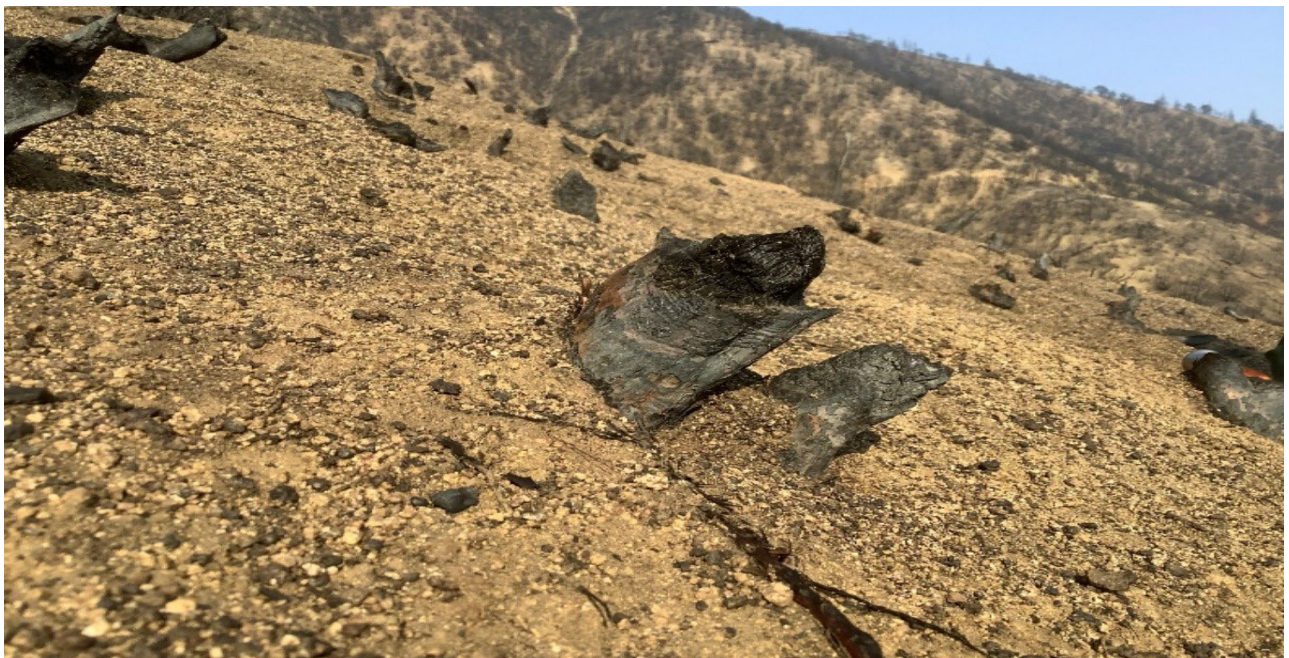
Figure 6 shows a manzanita stump where the very top is charred. After the erosion event, the unburned part of the stump was exposed.

Figure 6. Manzanita stump unburned portion exposed by extreme erosion

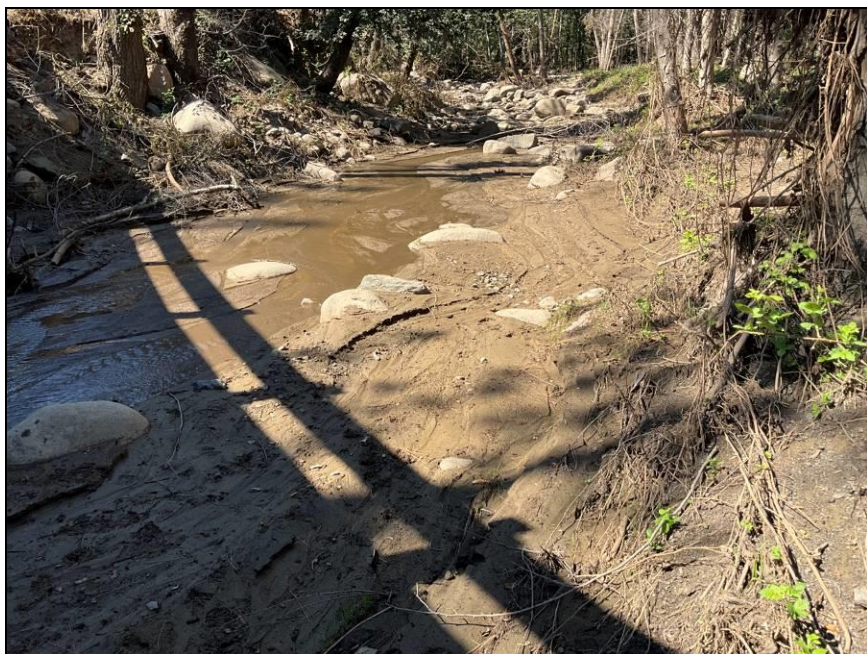
Photo 1. Mainstem Humbug Creek at the intersection with Hawkinsville Humbug Road. Debris flow sand and gravel deposits have filled the streambed and streamflow is forced to the surface through confined valley reaches.

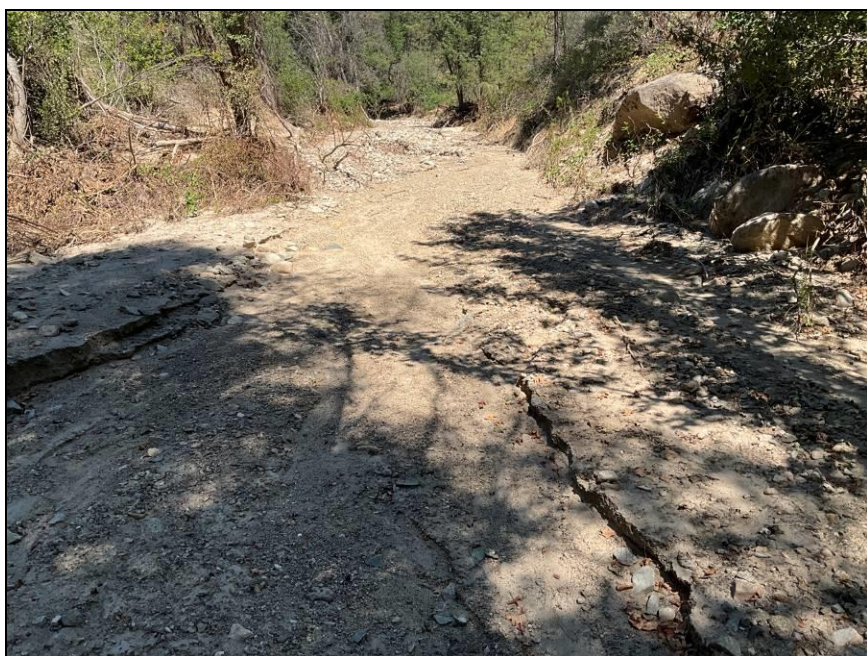
The Kennebec Gulch subbasin drains to Humbug Creek approximately 6 mi upstream from the Klamath River and is identified as the primary source basin for recent PFDFs which have affected salmonid habitat in Humbug Creek. Approximately 1.2 mi of Kennebec Gulch was directly observed by the assessment team to contain a significant volume of PFDF deposit consisting of subangular to subrounded granitic boulders, gravel, and sand.

Photo 2. Kennebec Gulch above Humbug Creek Road looking upstream.

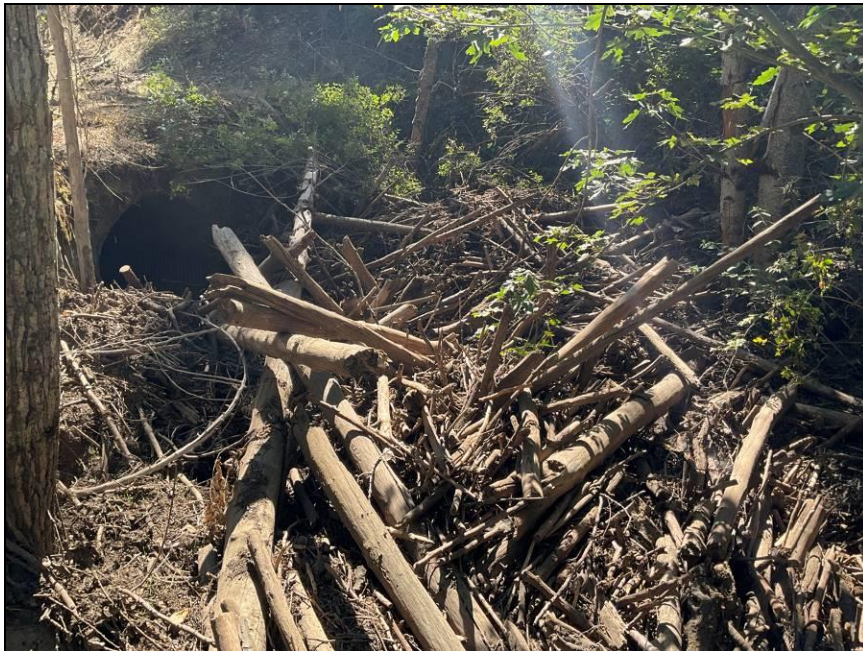
The culvert inlet at the Yreka Walker Road stream crossing on Middle Fork Humbug Creek was observed to have been recently unplugged by removal of accumulated woody debris. Woody debris was removed from the immediate culvert inlet area; however, a large accumulation of woody debris completely fills the stream channel for approximately 60 ft upstream of the culvert inlet (Photo 3). If the woody debris accumulation above the crossing is not completely removed prior to 2022-23 stormflows, the culverted crossing will be at extremely high risk of plugging, road prism failure, and delivery of eroded crossing material to the downstream channel.

Photo 3. Woody debris deposited upstream of the culvert inlet at the Yreka Walker Road crossing on Middle Fork Humbug Creek.

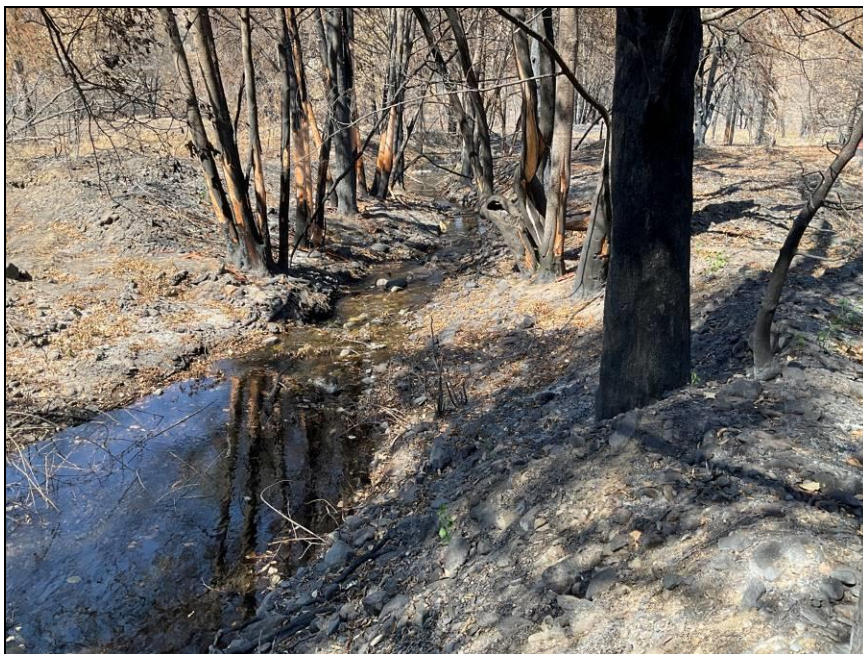
Conspicuously, no signs of post-fire sediment transport were observed in the Barkhouse Creek or McKinney Creek mainstem channels or along the inboard ditches of streamside or upslope roads within these watersheds (Photo 4). Anecdotal accounts of post-fire thunderstorm precipitation provided by residents state that intense precipitation within the burn area was isolated to the Humbug Creek, Little Humbug Creek, and Vesa Creek watersheds and little precipitation occurred within the Barkhouse and McKinney Creek watersheds. The observed focused concentration of intense rainfall is corroborated by historic radar data (Attachment B) and the observed lack of evidence of surface erosion and sediment mobilization within the McKinney Creek and Barkhouse Creek watersheds. Klamath River Road stream crossing structures at Barkhouse Creek and McKinney Creek did not appear to have been affected by PFDFs or post-fire flooding. No evidence of significant emergency maintenance was observed.

Photo 4. View of McKinney Creek looking upstream from Klamath River road. Evidence of accelerated sediment transport or sedimentation from August thunderstorm precipitation in the McKinney subbasin is not apparent in the mainstem channel.

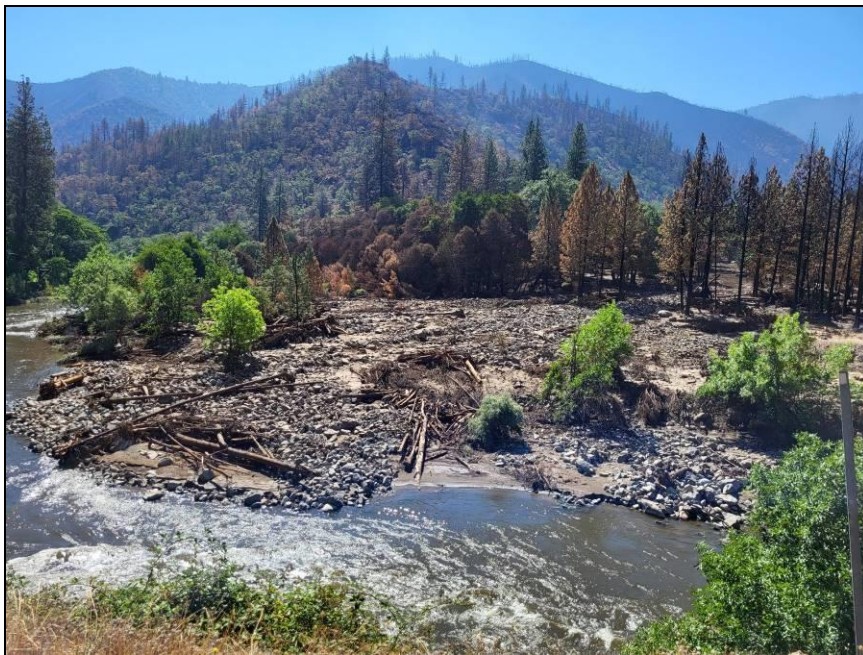
Within the floodplain of the Klamath River and downstream of Klamath River Road, PFDFs sourced in the Vesa Creek watershed have deposited in a large debris flow fan delivering to the Klamath River (Photo 5). The PFDF fan deposit, estimated as approximately 3 acres in area, is composed of a chaotic assemblage of granitic and gabbroic boulders ranging from 1.5 – 3 ft in diameter, sands, few fines, and woody debris ranging in size from small branches to whole trees. Given the large component of coarse boulder material and large woody debris, the debris flow fan shown in Photo 4 is interpreted as surge-front deposit. Sediment and ash delivery from the PFDFs sourced in Vesa Creek is believed to be a major factor in water quality impacts resulting in the post-McKinney Fire fish kill in the Klamath River downstream of the burn area.

No well-defined channel has yet developed across the debris flow fan deposit. Vesa Creek stormflows from the upcoming rainy season will undoubtedly reestablish at least one channel, if not several, through the fan deposit, delivering eroded PFDF deposit material directly to the Klamath River.

Photo 5. Distal end of post-fire debris flow fan at the Vesa Creek and Klamath River confluence. Photo provided by Alex Corum, Karuk Tribe Fisheries.

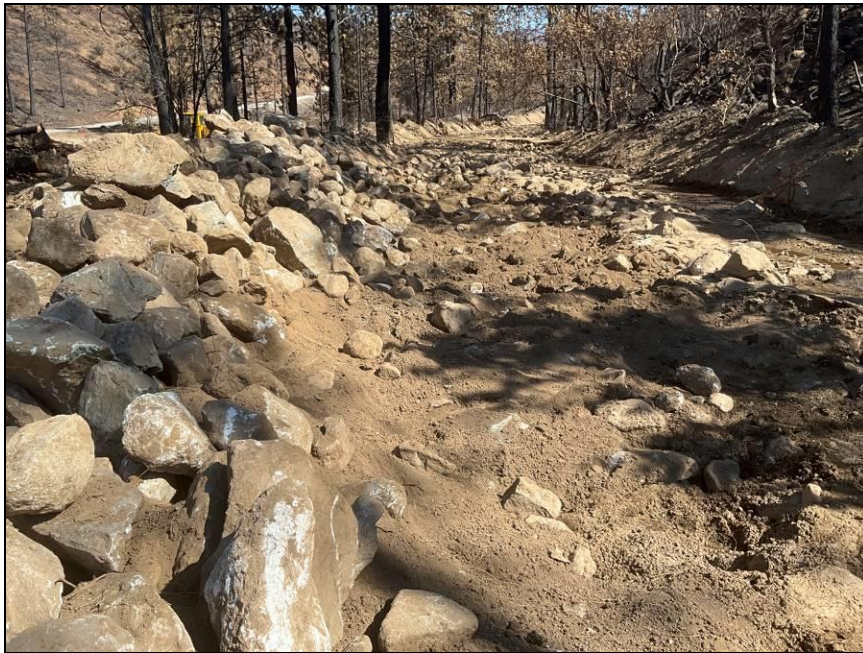
Lower Little Humbug Creek was also observed to have been severely impacted by PFDFs both upstream and downstream of Klamath River Road (Photo 6). Significant deposition of boulders and sand has filled the bankfull channel and spread to overbank areas. Post-fire emergency work has cleared the PFDF surge deposit from the bridge at Klamath River Road and constructed a large levee from coarse deposit materials along the right (east) side of the historic channel location. Streamflow currently flows onto and through PFDF deposit above the elevation of the widening stream valley as Little Humbug Creek flows onto the Klamath River floodplain. While the channel bed and banks of Little Humbug Creek downstream of

Klamath River Road have been exhumed from the PFDF deposit using heavy equipment, generally reestablishing the recent historic channel morphology, the upstream channel remains choked by PFDF deposit. PFDF materials used in emergency construction of the levee are highly porous and eventual failure of the levee due to soil piping and erosion and evacuation of sand size particles is anticipated if no further work is performed.

Photo 6. Photo of graded PFDF deposit in Little Humbug Creek looking upstream. A levee composed of porous PFDF deposit materials has been constructed to constrain surface streamflow and direct streamflow to the bridge crossing at Klamath River Road.
